4. Receiver Maladjustments.

5. Receiver Faults.

7. Interference from External Sources.

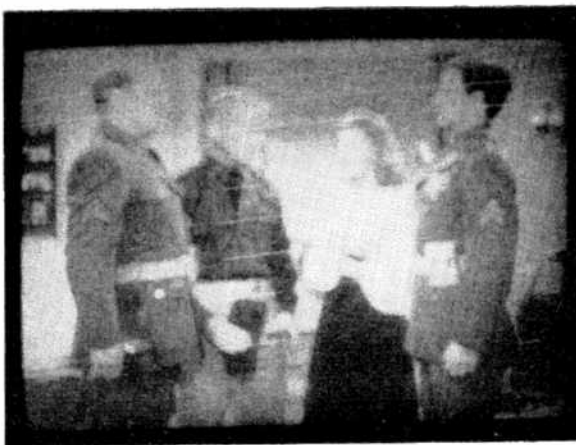
FIG. 1. BRIGHTNESS CONTROL TOO FAR ADVANCED
The definition is poor and flyback lines appear on the picture.

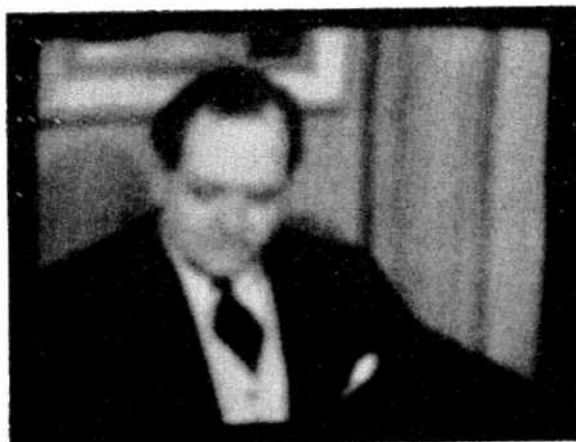
FIG. 2. INCORRECT FOCUSING
The line structure is not visible and there is loss of resolution in the picture.

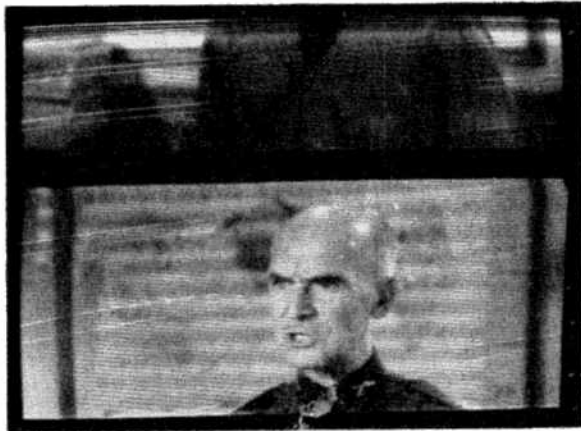
FIG. 6. FRAME (OR VERTICAL) HOLD CONTROL INCORRECTLY ADJUSTED

The interlacing is incorrect and generally causes the picture to move vertically up or down at a speed depending upon the degree of maladjustment of the control. This effect may also be caused by insufficient signal due to a receiver or aerial fault. The picture sometimes remains steady, showing a horizontal black bar across the screen.

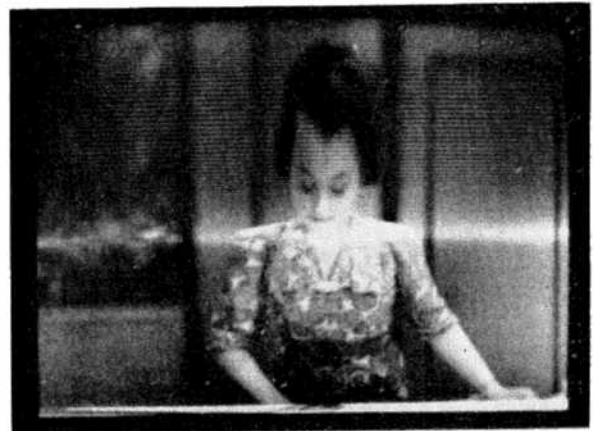
FIG. 8. FRAME LINEARITY CONTROL INCORRECTLY ADJUSTED

The top of the picture is expanded. The lines can be seen to be farther apart, and the effect is most noticeable when there is a vertical movement in the picture.

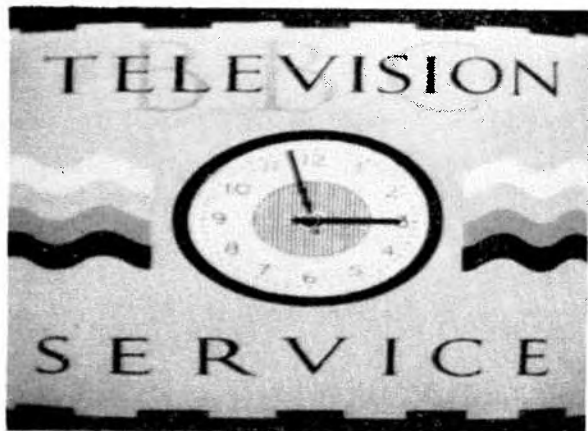
FIG. 9. LINE AMPLITUDE (OR PICTURE WIDTH) CONTROL INCORRECTLY ADJUSTED

Picture expanded or contracted horizontally. The illustration shows expansion.

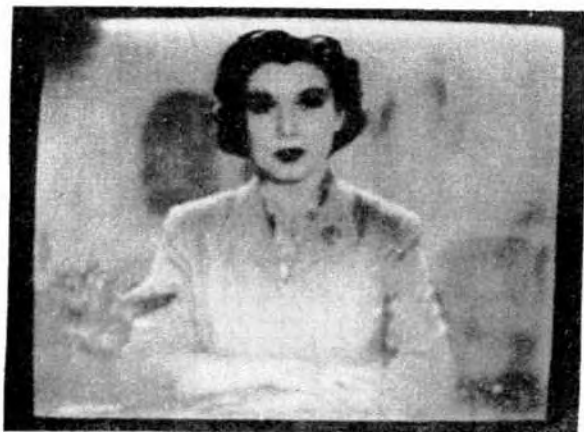
FIG. 11. VISION INTERFERENCE LIMITER CONTROL TOO FAR ADVANCED

The video signal is clipped at grey level, and no highlights can be seen in the picture.

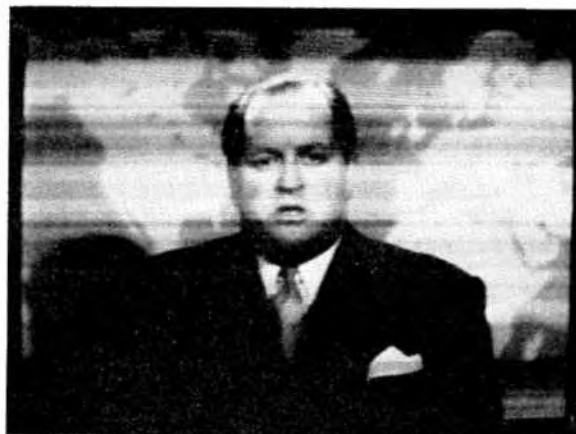
FIG. 12. SOUND ON PICTURE

This fault is made apparent by the presence of light and dark bands across the picture, which vary in intensity in accordance with the loudness of the sound. This fault is often due to poor sound rejection in the vision channel, but the effect is sometimes produced mechanically by sound waves from the loud-speaker vibrating faulty or loose components in the video stages.

SYMPTOM	PROBABLE CAUSE	SEE FIG. No.
Patterning	Sound on picture	12
	Interference from valve-type diathermy apparatus ...	24, 25 and 26
	" " a vacuum lamp	27
	" " R.F. heating apparatus	28
	" " radio transmitter or superheterodyne receiver	33, 34 and 35
" Ghost " images	Feeder-cable of incorrect impedance in use	29
	Multipath reception	29, 30 and 31

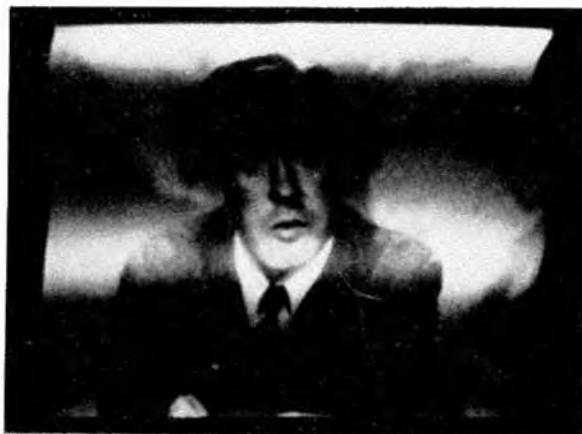
FIG. 13. HUM BARS

The number of dark bands on the picture resulting from hum is dependent upon whether full or half-wave rectification is used in the power supply. Fig. 13 shows the effect of faulty smoothing of a full-wave H.T. supply. Alternate dark and light stationary bars appear if the picture is locked, and the vertical edges of the picture are curved as shown. Faulty smoothing of the cathode-ray tube E.H.T. supply (half-wave) causes a single dark band to appear if the picture is locked. If the picture is not locked, the dark bands move vertically over the screen.

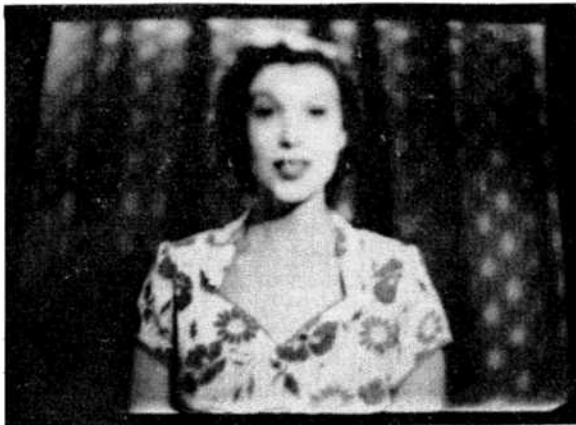
FIG. 14. POOR E.H.T. REGULATION

The effects are :—

(a) The value of the E.H.T. voltage varies with picture content, being lower for the part of the picture (i.e. the white part) where the beam current of the cathode-ray tube is high. Consequently, at this part the deflexion sensitivity is higher and the picture width is increased.

(b) Because of the changing E.H.T. voltage the picture only focuses at one particular level of brightness. Brighter and darker parts of the picture are out of focus.

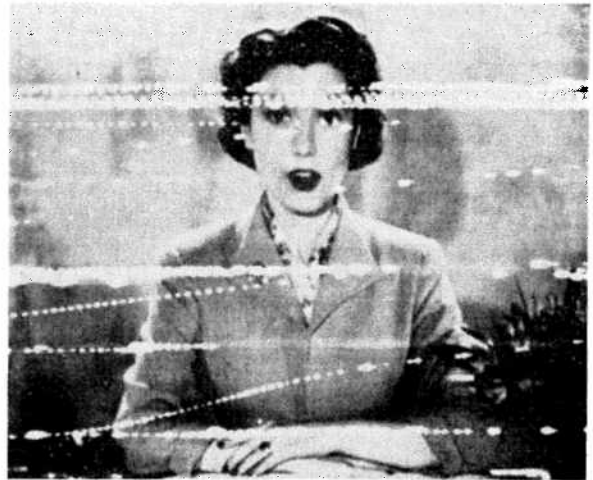
FIG. 15. IGNITION INTERFERENCE

Ignition interference produces high-intensity white dots which may occur in bands moving up or down the picture or as many isolated spots all over the picture.

(a) Interference similar in appearance to that caused by car ignition (see Fig. 15), accompanied by a crackling on the sound channel, caused in some cases by faulty insulation in the "pinch" of the line or frame output valves.

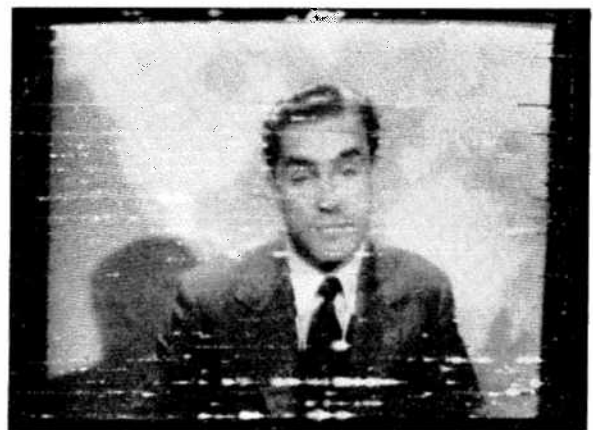
Figs. 16, 17 and 18 show the effects of interference from various types of commutator motors. A sewing-machine motor causes two fairly well-defined broad horizontal stationary bands of white spots to appear anywhere on the picture (Fig. 16). This interference is usually intermittent and of short duration with distinctive starting "splashes". The bands caused by a hair-drier motor (Fig. 17) are not so clearly defined and the duration may vary from a few minutes to an hour. The interference from an electric drill motor (Fig. 18) usually occurs in short bursts and is more intense than that from either a hair-drier or a sewing machine.

FIG. 16. INTERFERENCE FROM A SEWING-MACHINE MOTOR

FIG. 17. INTERFERENCE FROM A HAIR-DRIER MOTOR

FIG. 18. INTERFERENCE FROM AN ELECTRIC DRILL MOTOR

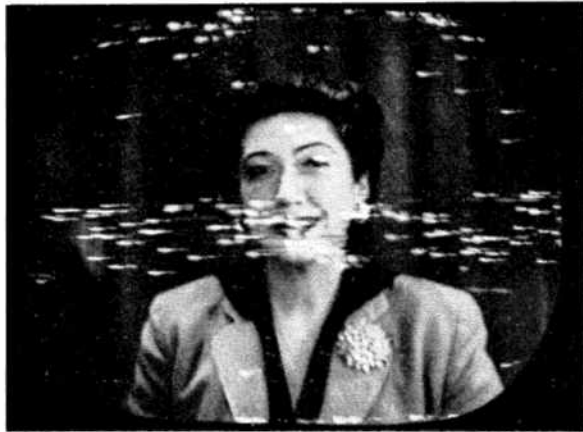
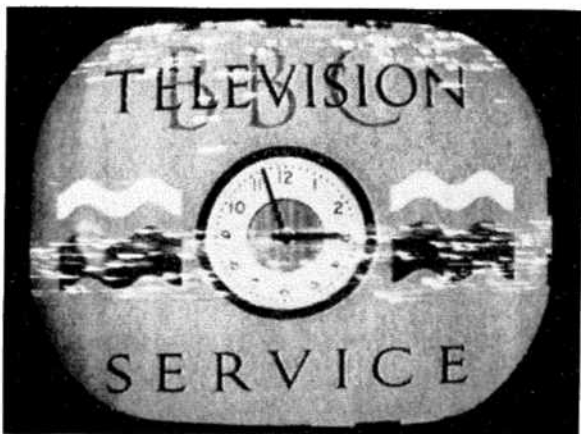
Figs. 20 and 21 show the effects of discharge across insulators of high-voltage overhead power-lines. These effects are similar to those caused by commutator interference, but the bands are very clearly defined and the interference is normally intermittent, recurring at intervals of several seconds. Interference caused by neon signs produces similar effects.

FIG. 20. INTERFERENCE FROM HIGH-VOLTAGE OVER-
HEAD POWER LINES

FIG. 21. INTERFERENCE FROM HIGH-VOLTAGE OVER-
HEAD POWER LINES

(b) Interference due to corona or breakdown within the receiver, producing a somewhat similar effect to E.H.T. power-line brush-discharge (see Figs. 20 and 21), but appearing as a vertical band over the picture. This effect, which may be continuous or present only in humid weather, is caused by ionization at a high-voltage point during the flyback.

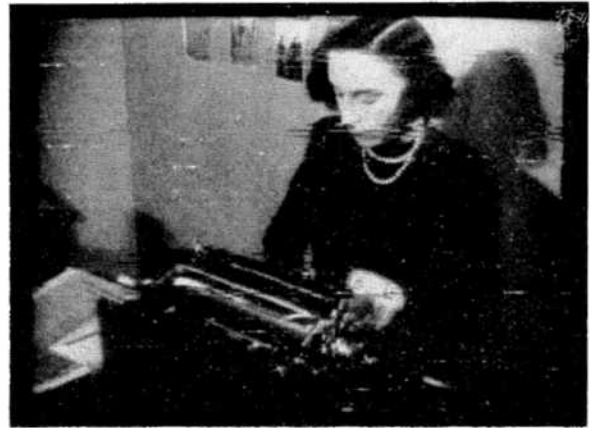
FIG. 22. INTERFERENCE FROM VIOLET-RAY EQUIP-
MENT

Interference from this source produces lines of white dots across the picture which move up or down in a random fashion for periods of up to 20 minutes.

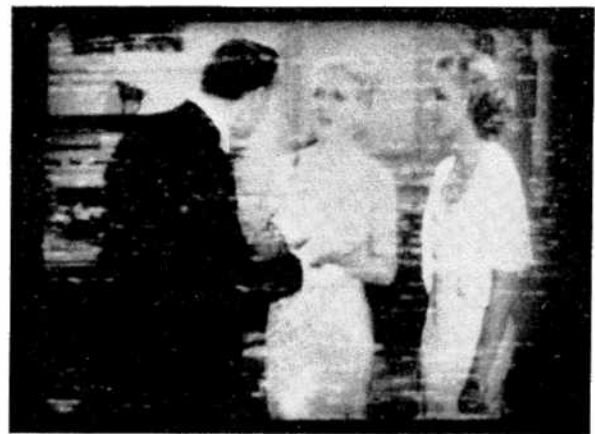
FIG. 23. INTERFERENCE FROM SPARK-TYPE
DIATHERMY APPARATUS

The effect of this type of interference is very similar to that produced by commutator motors. This type of interference usually persists for periods of up to 20 minutes.

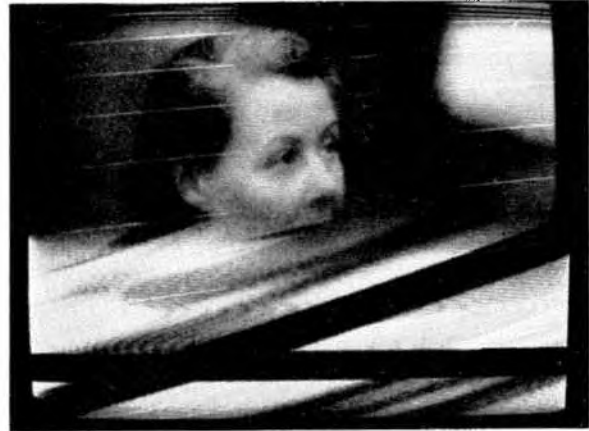
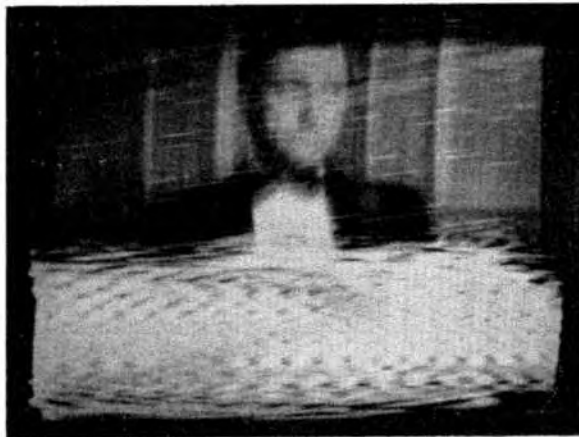
FIG. 24. INTERFERENCE FROM VALVE-TYPE
DIATHERMY APPARATUS (UNSMOOTHED H.T.)

FIG. 26. INTERFERENCE FROM VALVE-TYPE
DIATHERMY APPARATUS

Usually a broad band of interference, horizontal and stationary, occupies about half the picture area (Figs. 24, 25 and 26). If the intensity is high, one half of the picture may be nearly all white, but unless the interference is severe the typical changing pattern can be seen. In its severe form it can cause the picture to lose synchronism.

The interference causes a characteristic hum on the sound channel, not unlike the sound of the picture transmission. The interference may be present for up to 20 minutes at a time.

FIG. 25. INTERFERENCE FROM VALVE-TYPE
DIATHERMY APPARATUS

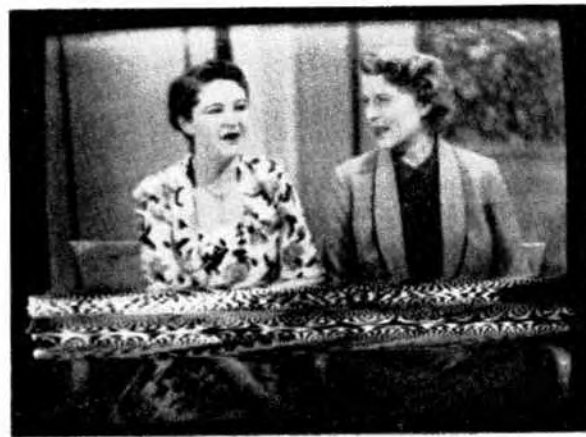
FIG. 27. INTERFERENCE FROM A VACUUM LAMP
An oscillating lamp produces a distinctive type of pattern on the picture in very narrow bands.

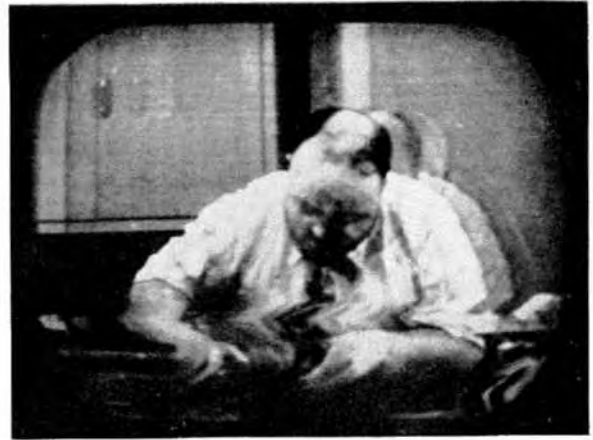
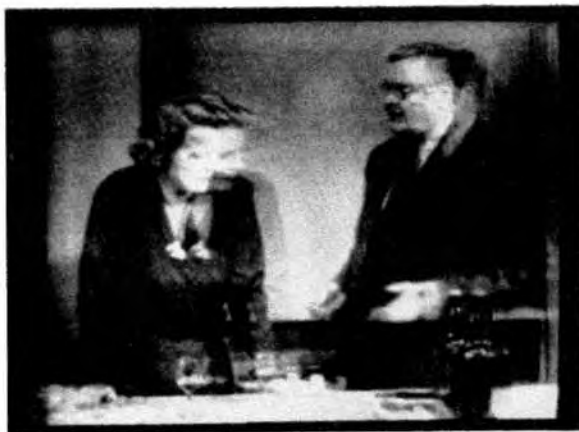
FIG. 31. MULTIPLE IMAGES CAUSED BY MULTI-PATH RECEPTION

Fig. 29 shows a second image to the right of the main picture. This second image is due to the reception of a reflexion of the signal. Figs. 30 and 31 show second and third images caused by two reflexions of the signal being received. The main signal is received direct from the transmitter and the others arrive slightly later, being reflected from high ground or some prominent structure such as a gas-holder, a power-station cooling-tower or from an aeroplane. The ghost picture may be a positive or negative reproduction of the picture. It will be seen in Fig. 30 that the first reflexion (second image) is negative and that the second reflexion (third image) is positive. Fig. 32 shows a section of a map of the actual location in which the ghost images illustrated in Figs. 30 and 31 were experienced. Replacing the original half-wave dipole by a dipole and reflector, suitably orientated, eliminated the interference, but it has sometimes been necessary to use a more complex directional aerial system. Reflexions caused by aeroplanes produce violent fluttering or wavering of the picture, but this effect only lasts for a short period.

FIG. 29. MULTIPLE IMAGES CAUSED BY MULTI-PATH RECEPTION

FIG. 30. MULTIPLE IMAGES CAUSED BY MULTI-PATH RECEPTION

(c) Double images may be caused by impedance-mismatch between aerial-feeder and receiver, but are usually caused by multi-path reception (see Figs. 29 to 31).

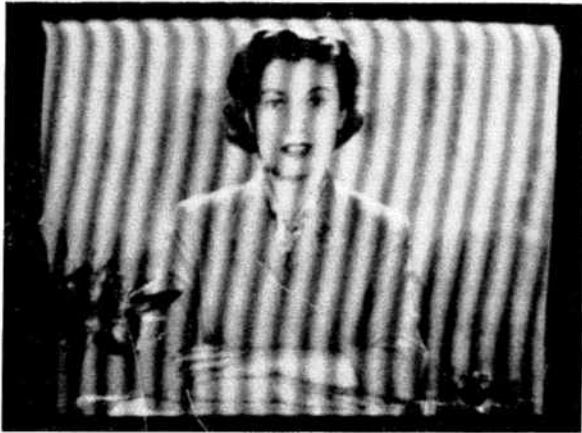
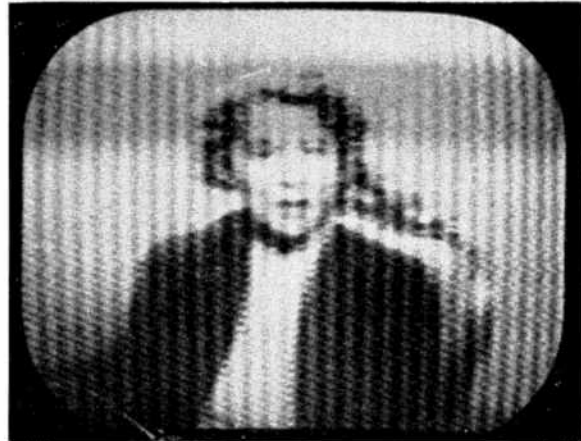
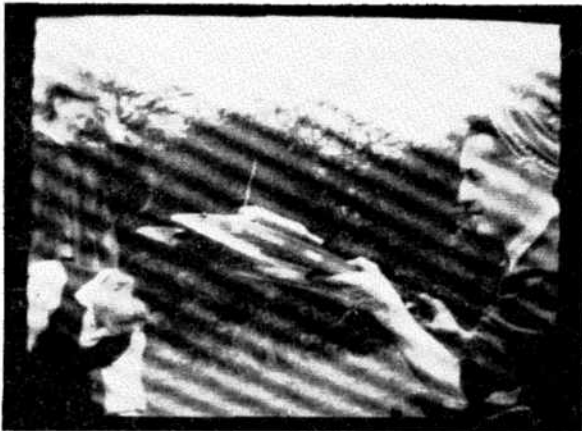
FIG. 33. RADIO TRANSMITTER INTERFERENCE

FIG. 35. RADIO TRANSMITTER INTERFERENCE

FIG. 34. RADIO TRANSMITTER INTERFERENCE

The pattern caused by radio-transmitter interference does not usually remain stationary. The lines do not remain in one position, but often wander through varying angles across the screen. Another source of interference giving a similar pattern is the local oscillator of a nearby superheterodyne receiver. The duration of the interference varies considerably.

(d) Self-oscillation caused by faulty decoupling capacitors, producing oscillatory patterns on the screen (see Figs. 33 to 35).
